**FACILITY AUDIT & MASTER PLAN**

**RANDOLPH PUBLIC SCHOOLS**

**MARCH 11, 2024**

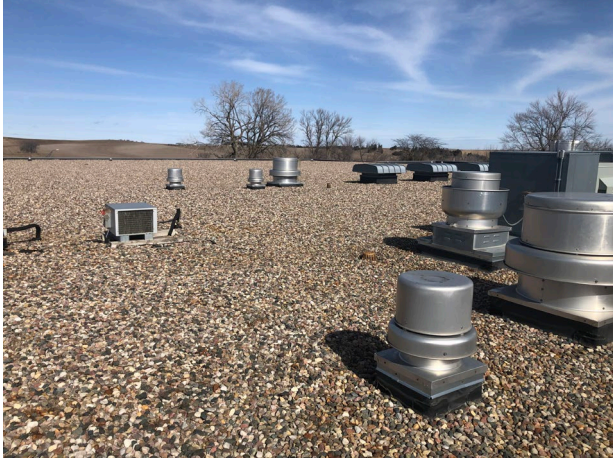
Ballasted EPDM

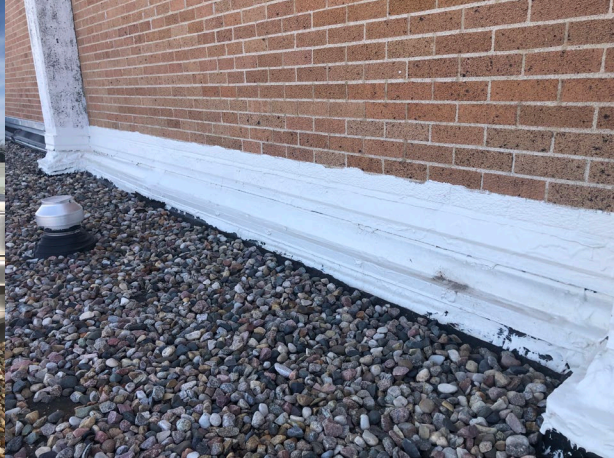
Leaks at the original gymnasium north wall can not be stopped in this fashion. The wall must be sealed and a rain screen added.

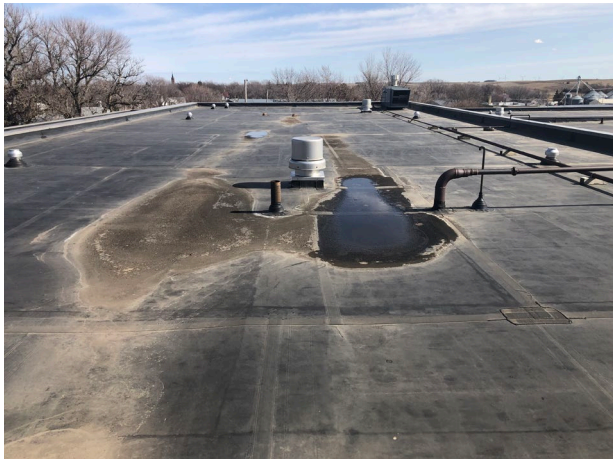
Fully adhered EPDM / standing water should be eliminated

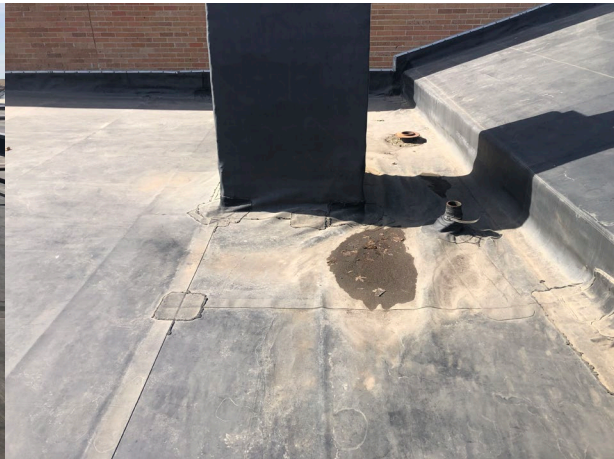
does have a few standing water areas as well. When this roof was last replaced, the roofer covered an area of structural damage around the existing chimney just east of the original gymnasium. The structural metal deck in this area is completely rusted through and presents a hazard to anyone walking around the chimney area. This decking needs to be replaced. During replacement the roof bar joists should be inspected for damage as well. Any damage found should be investigated by a structural engineer. The new gymnasium and commons area is covered by a ballasted EPDM roof. A ballasted roof is this architect's least favorite roofing system and is personally never specified. A ballasted roof requires tons of rock to hold the roofing membrane in place. This extra weight requires the roof structure to be more robust which costs additional money. The foundation and supporting structure also must be stronger, again costing additional dollars. The system is more labor intensive as massive amounts of rock must be lifted onto the roof and spread evenly. When a roof leak occurs the source of the leak can be harder to find as rock must be moved in order to locate the leak. Lastly, rock slows the movement of water and creates low spots for water to be trapped increasing leak potential. When this roof is ready for replacement it is recommended that the district use a fully adhered EPDM or TPO roof.

The roof deck around this chimney has completely rusted through. Standing water in this area is evident and was likely a contributing factor

1. Evaluate the extent of structural damage around the existing chimney. Repair/replace decking, insulation, and roofing as needed.
2. One section of the roof has not been updated. There is currently a leak where the lower roof abuts the original gymnasium. Also, investigate potential mold/roof leak along west wall of north gymnasium.

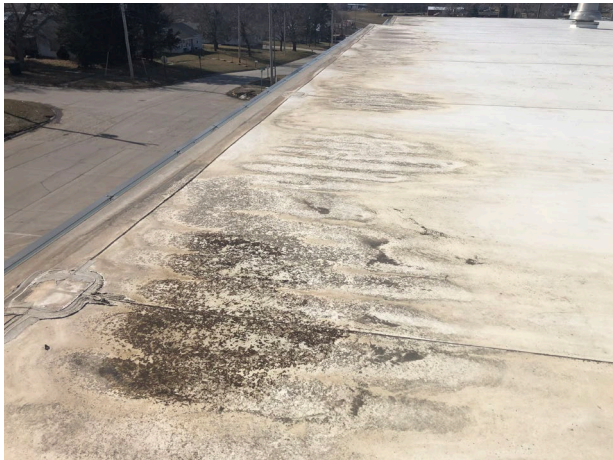
Fully adhered TPO / standing water should be eliminated

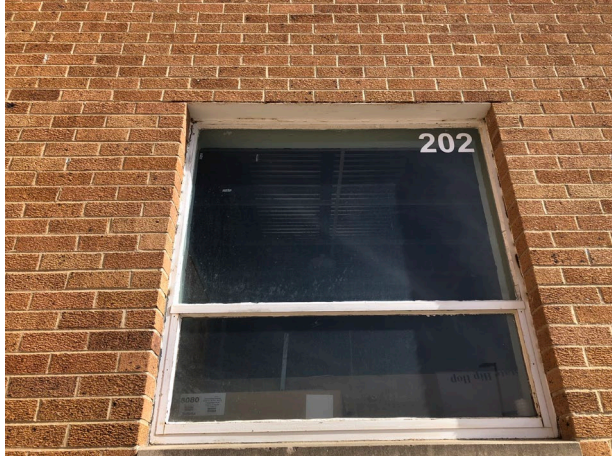
Sealant around window is deteriorating

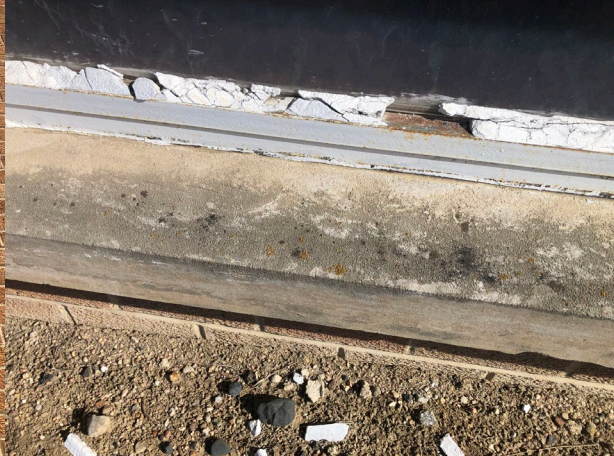
Sealant is no longer flexible

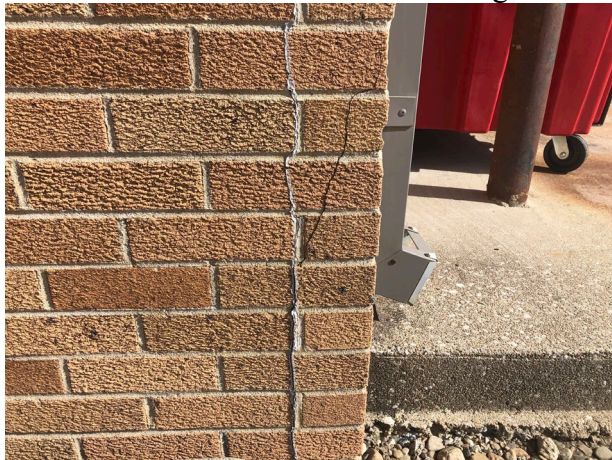
Crack in brick

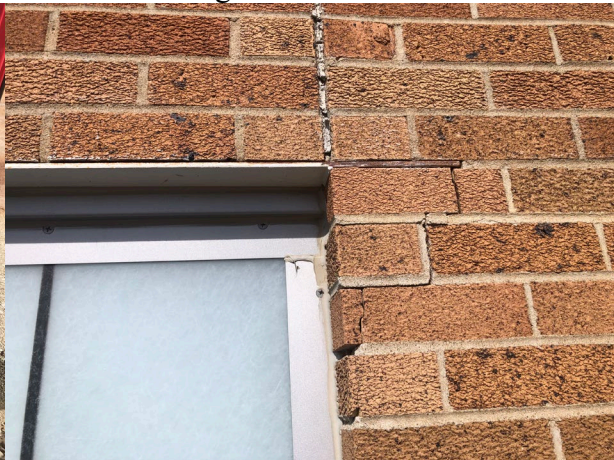
Control joint sealant has failed  
The steel lintel is rusting which leads to expansion and brick cracking

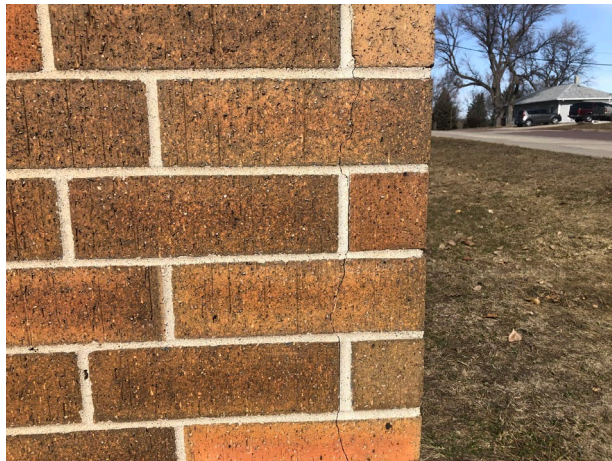
Crack in brick

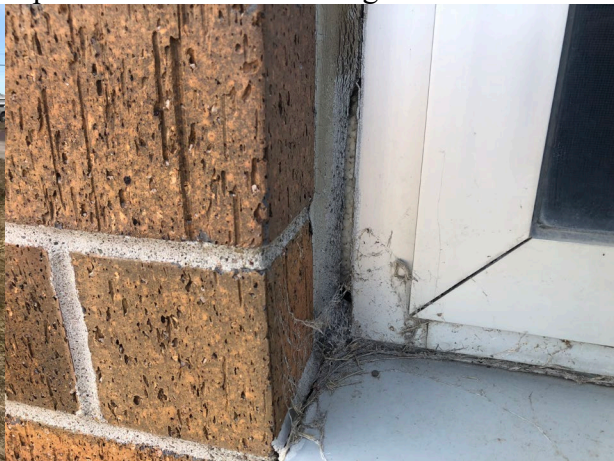
Stress cracks in sealant show that it is losing its flexibility

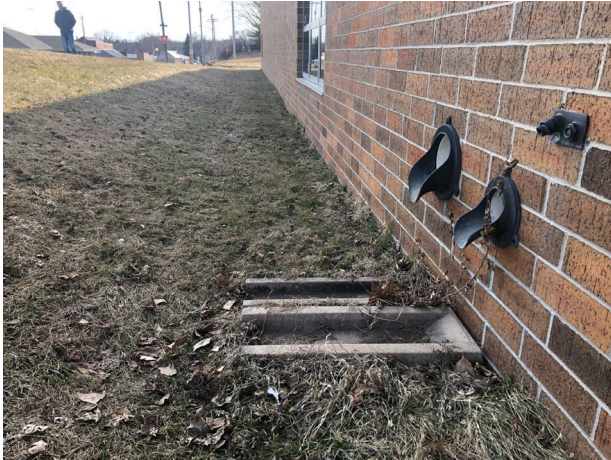
Grade on the east side of the building is running toward the building

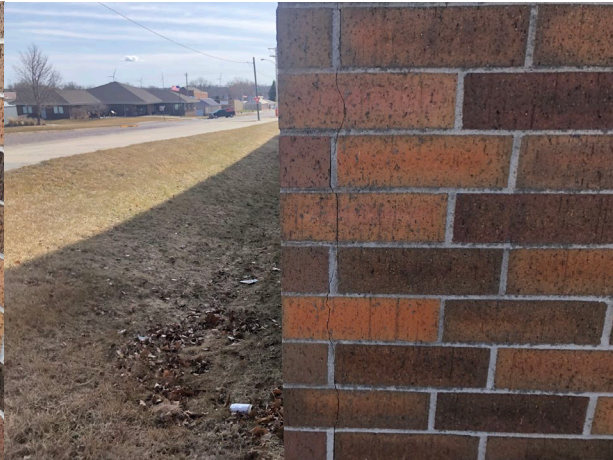
Crack in brick

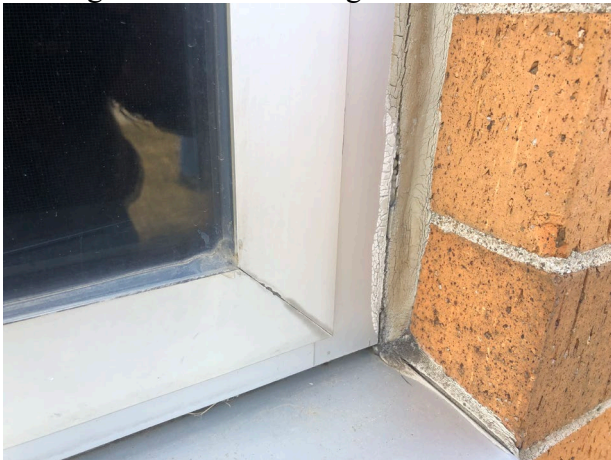
Sealant beginning to pull away from window

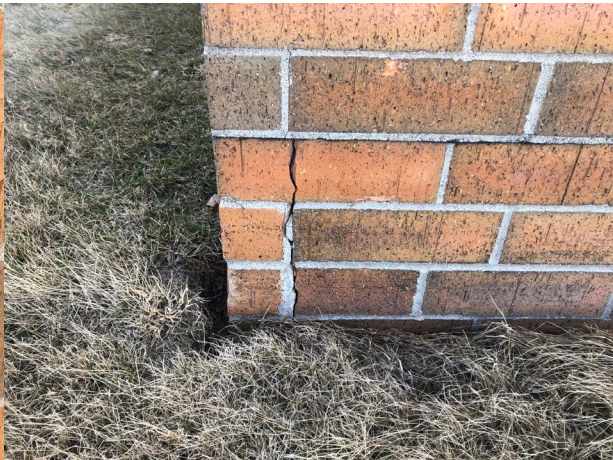
Crack in brick / grade does not slope away

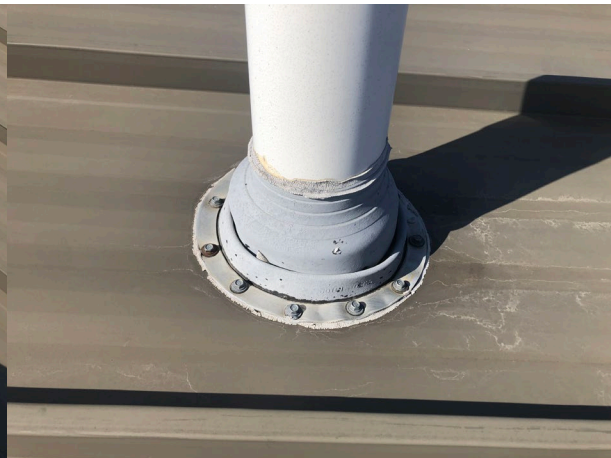
Sealants drying out and starting to crack

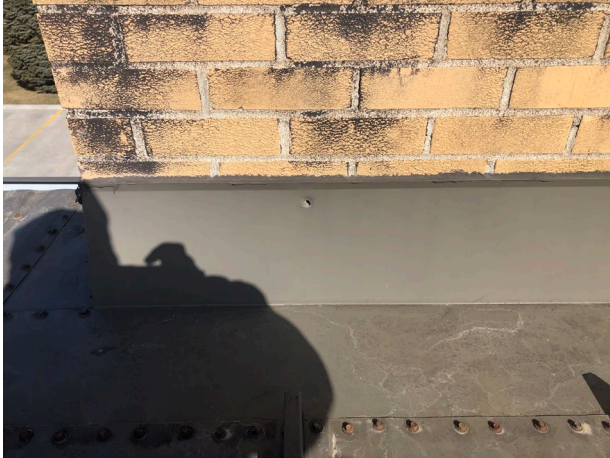
Missing fastener leaves hole in flashing

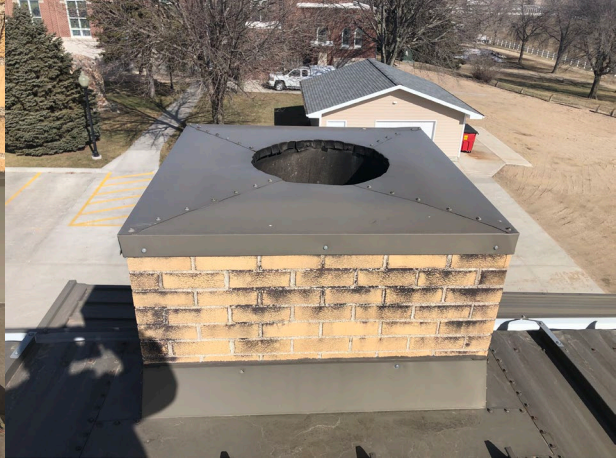
Chimney does not have a rain cap

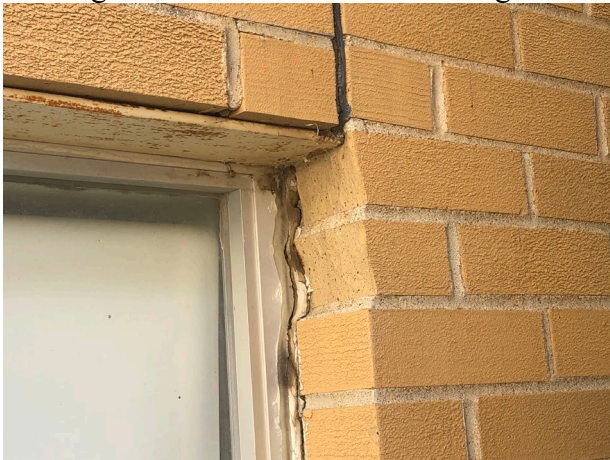
Broken bricks at window corners

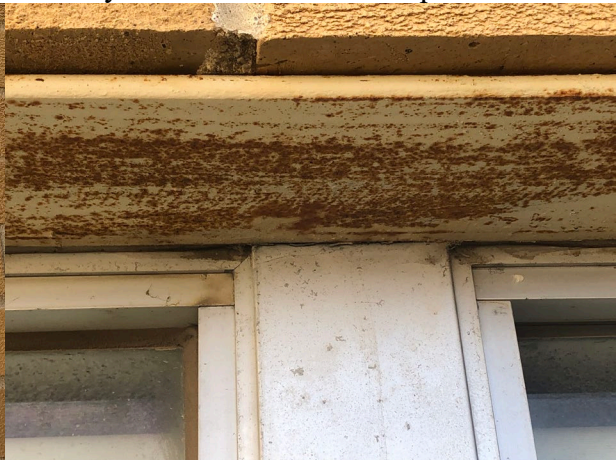
Steel window lintels starting to rust

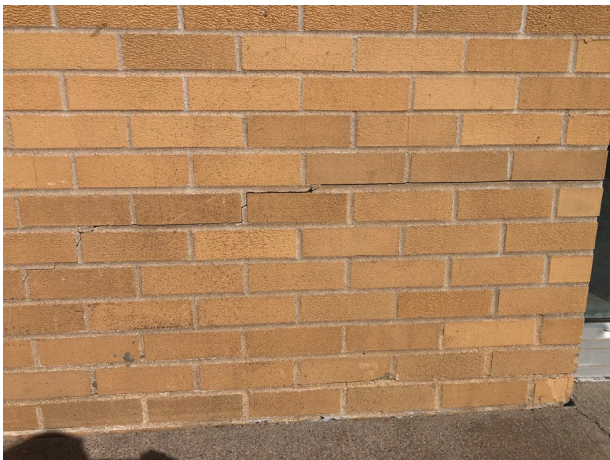
Horizontal crack in mortar joint

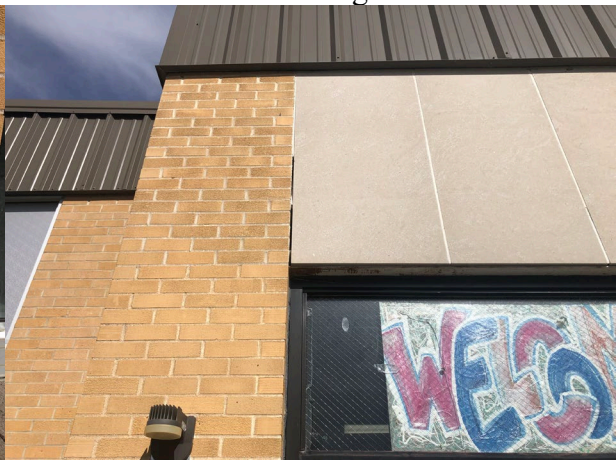
Sealant missing

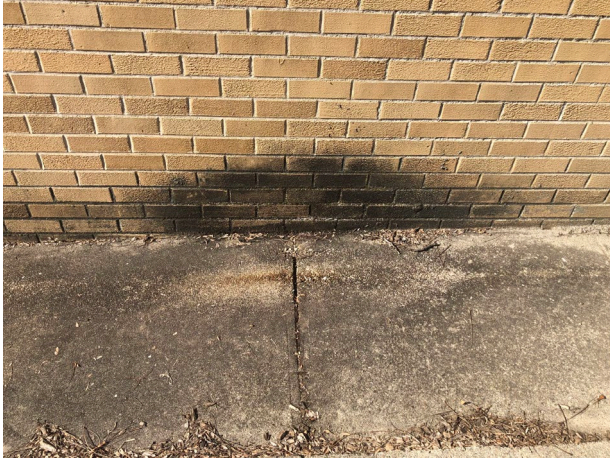
Algae on wall and sidewalk deteriorating under gutter seam that is leaking

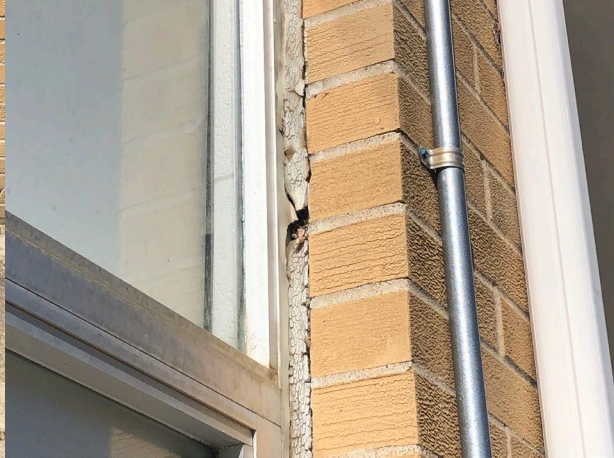
Deteriorating sealant at windows

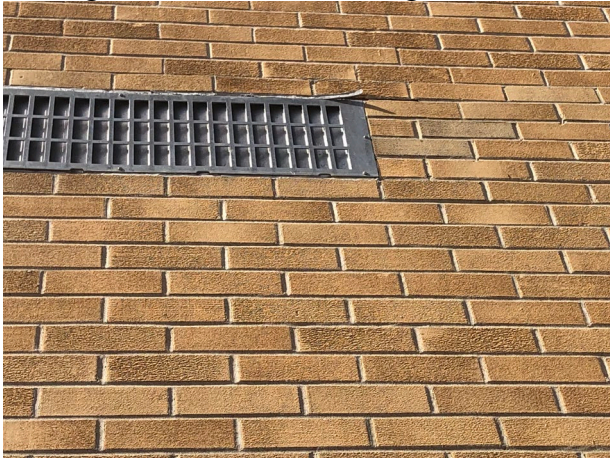
Deteriorating sealant

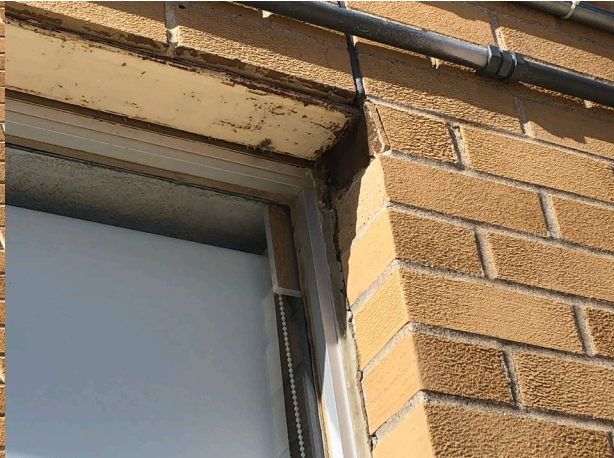
Cracked brick at window head

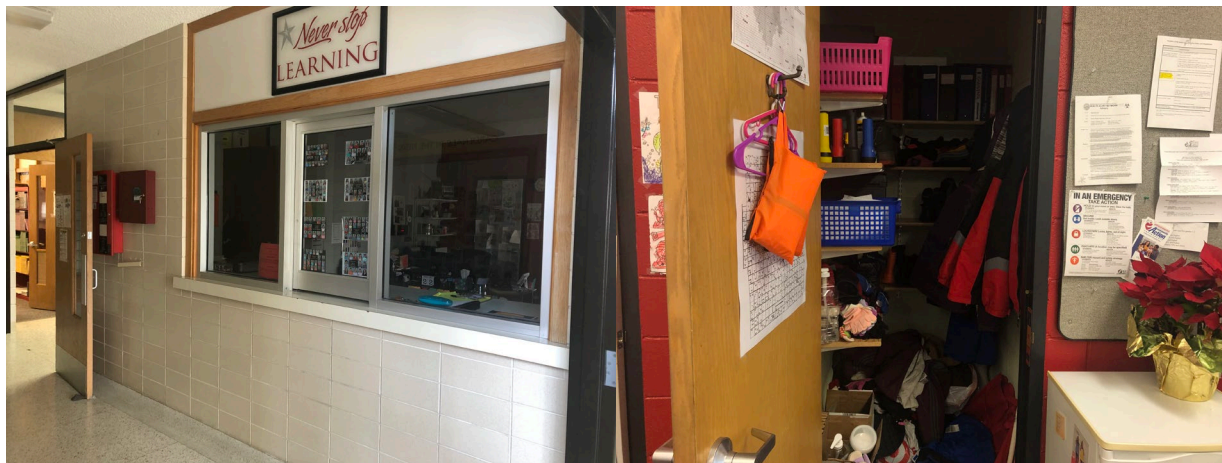
Reception desk is outside the entry vestibule      Administration space lacks adequate storage  
The desk height is too tall to meet ADA

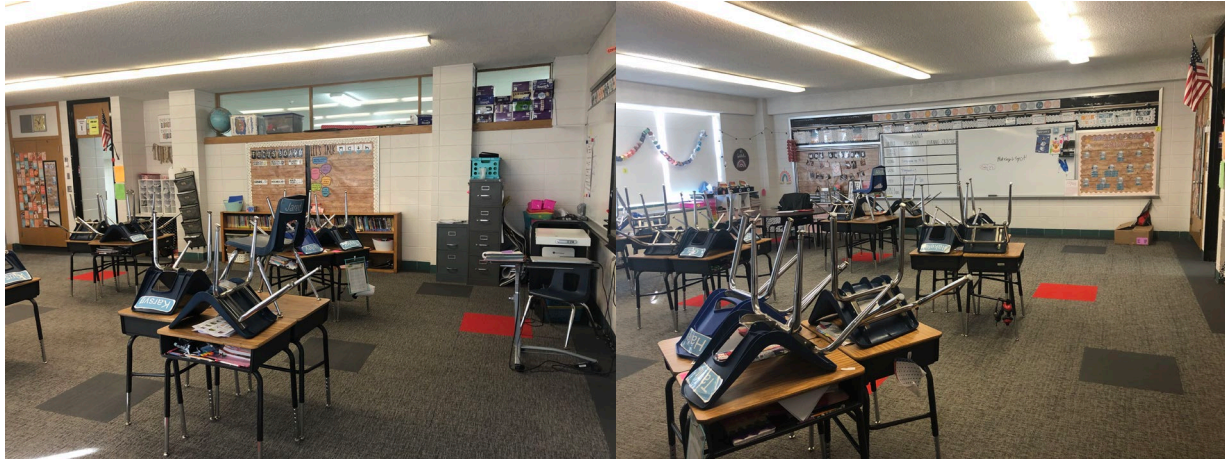
Typical classroom without built-in storage

13. Add classroom storage cabinets.

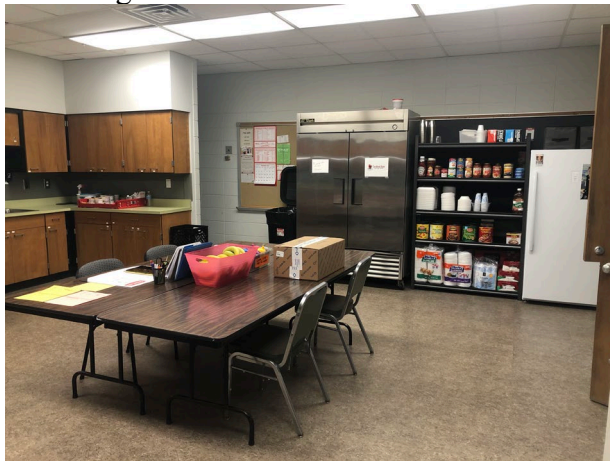
Washers and dryers are not allowed in kitchens according to the Nebraska Food Code

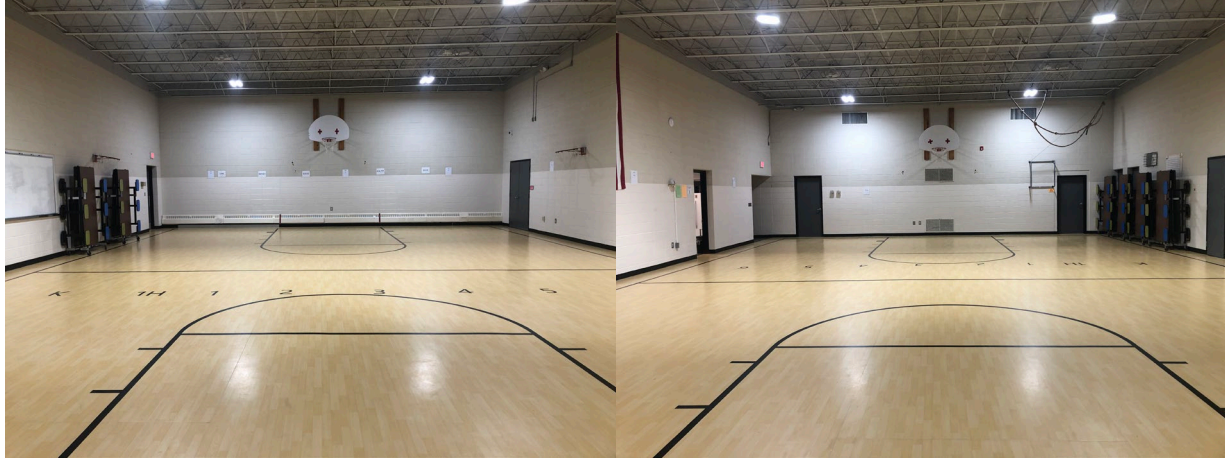
Out of bounds space lacking, no storage for dining tables, poor lighting, no wall padding and no bleachers.

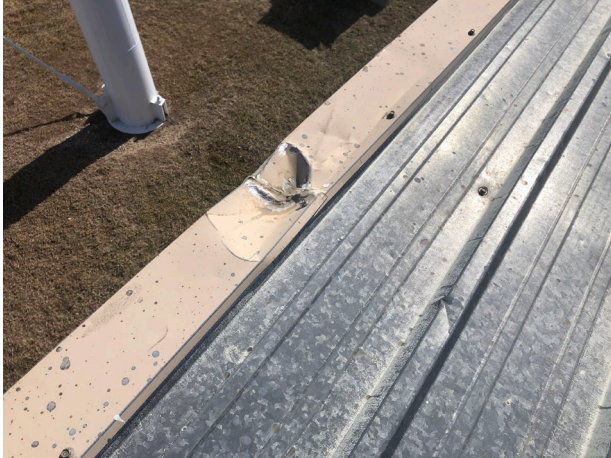
Roof damage

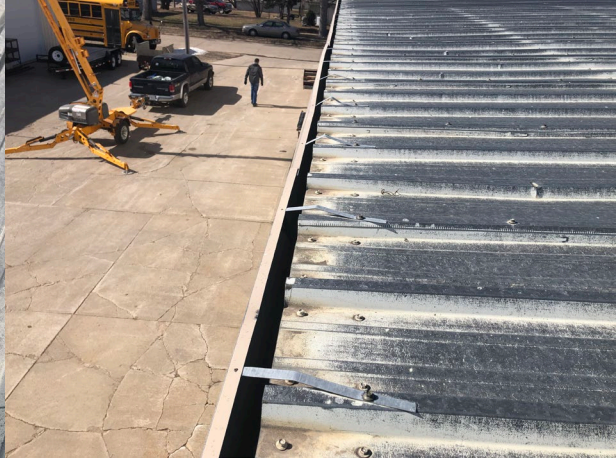
Loss of finish

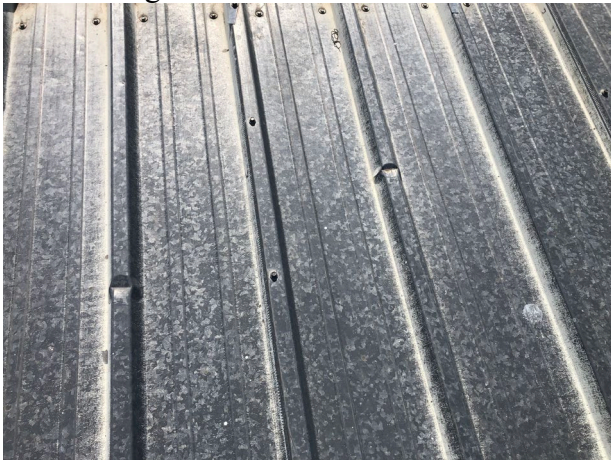
Hail damage upper right and rib damage

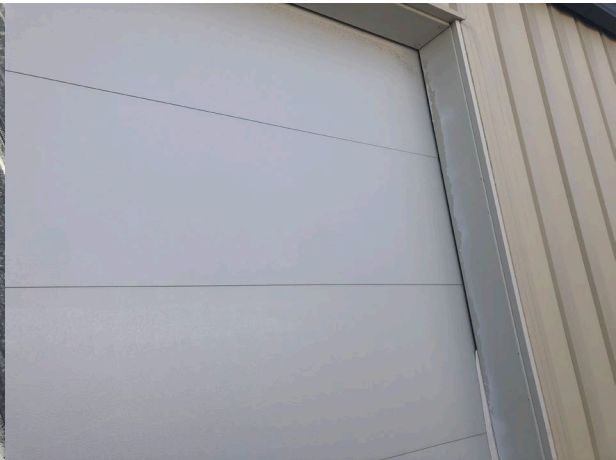
Missing and damaged weather seals

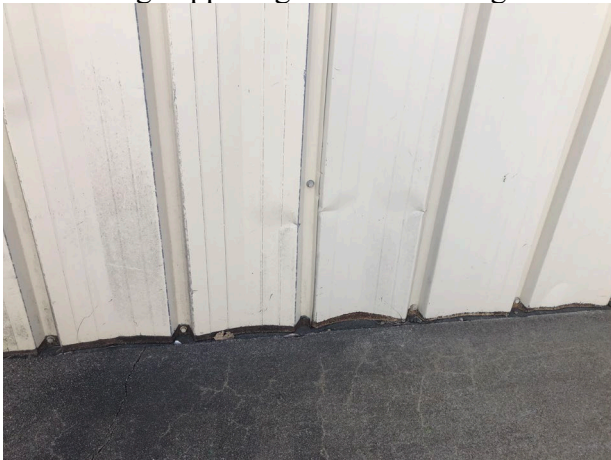
Typical siding damage

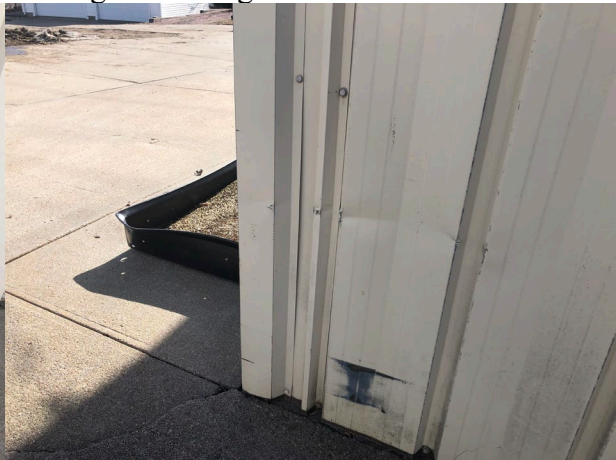
Typical siding damage

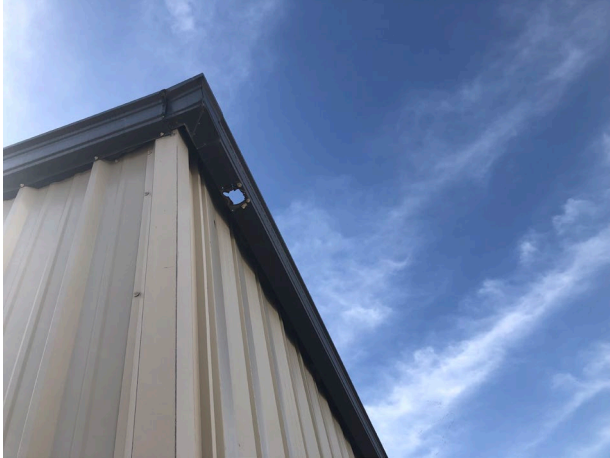
Missing downspout

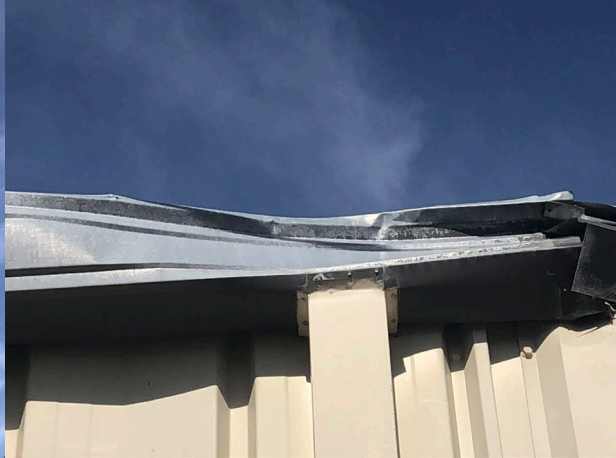
Gutter damage

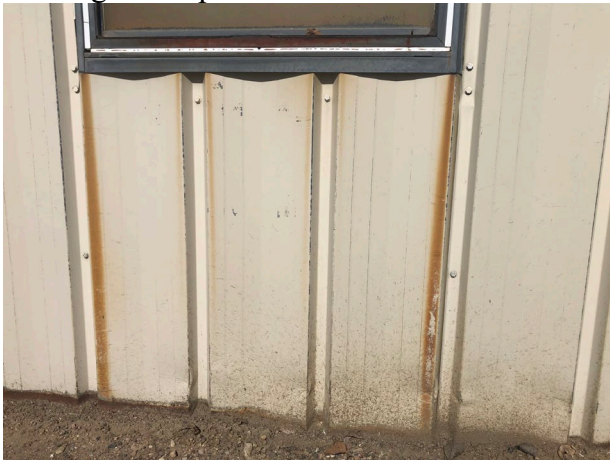
Grade to high panels buried in dirt – rust

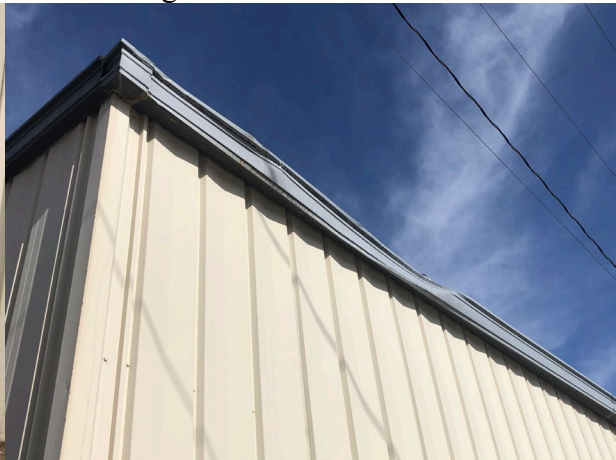
Gutter damage

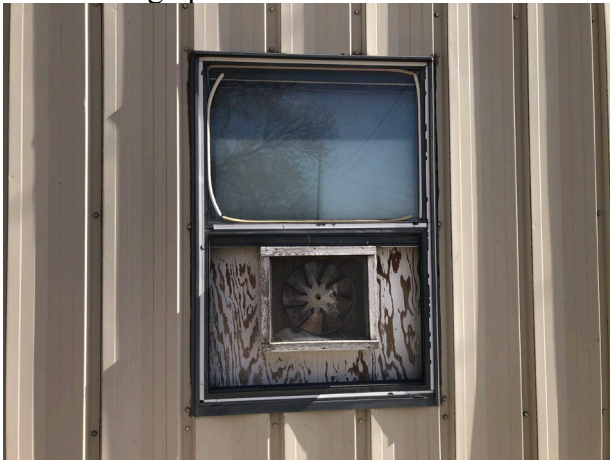
Deteriorating window seals

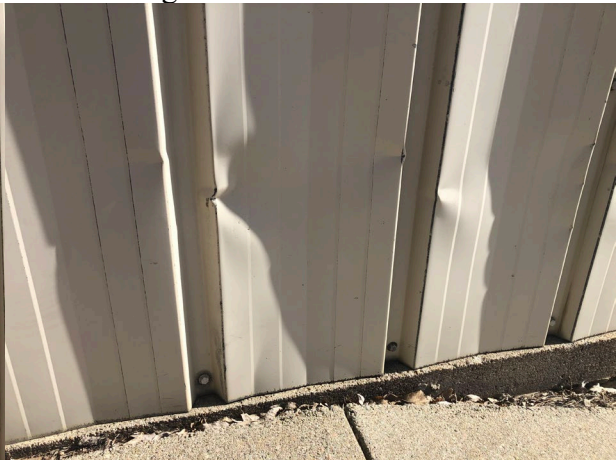
Typical siding damage

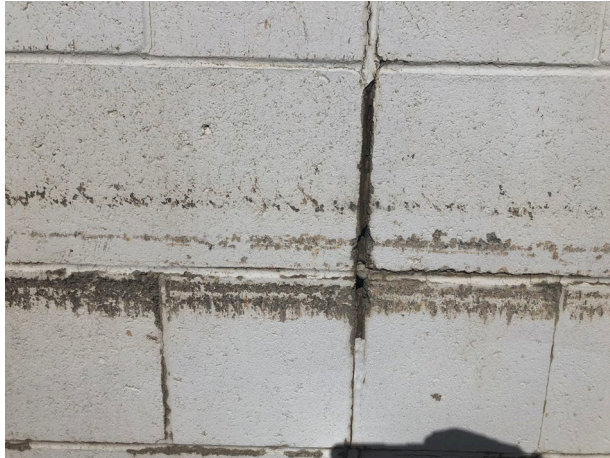
Soft joints in masonry deteriorating

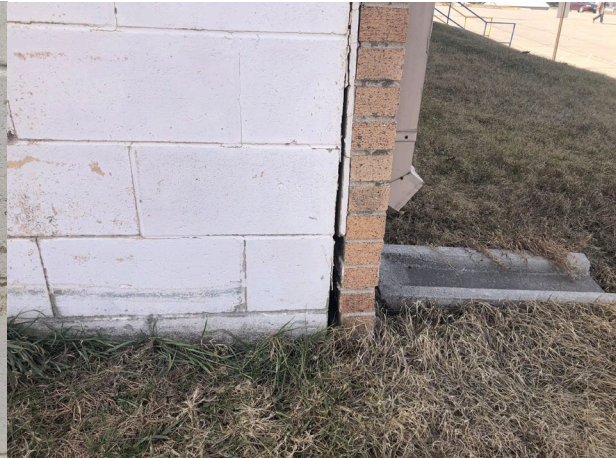
Movement of CMU/brick veneer

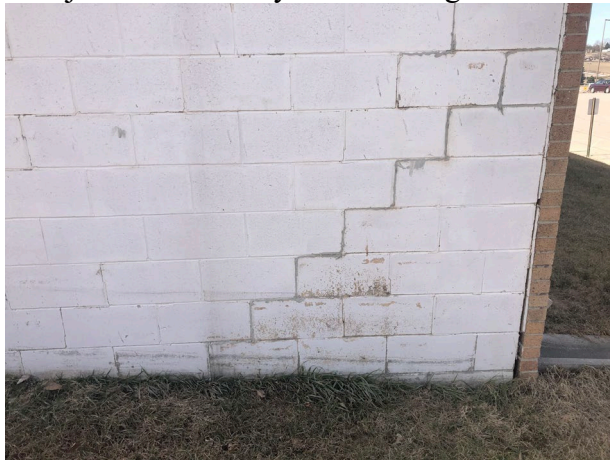
Typical mortar joint cracking in CMU

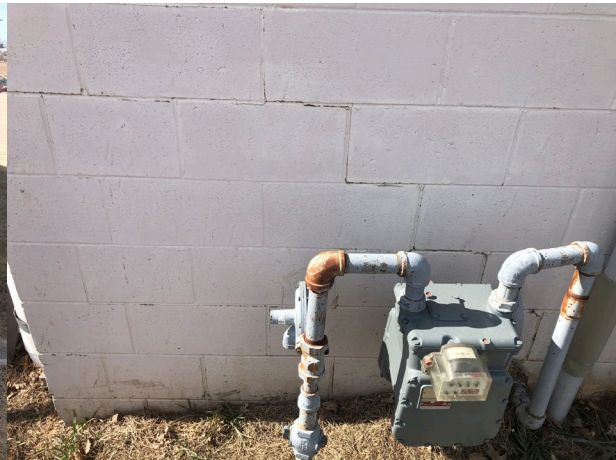
Typical mortar joint cracking in CMU

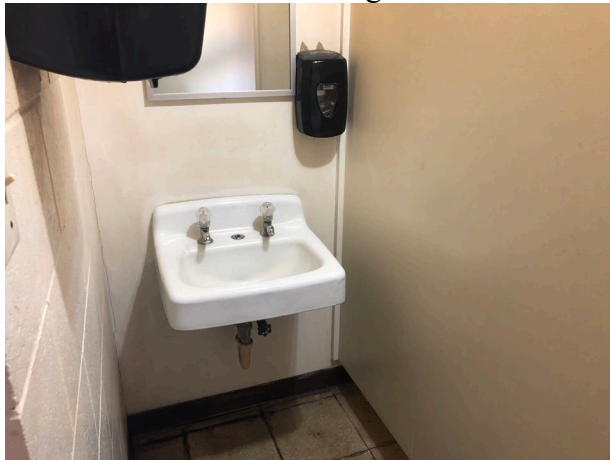
No insulation on lavatory piping to prevent burns, mirror set too high, paper towel dispenser set above reach range.

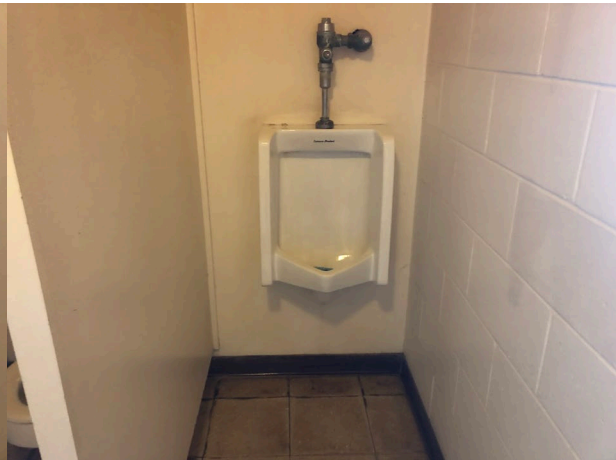
Urinal rim set too high to meet ADA

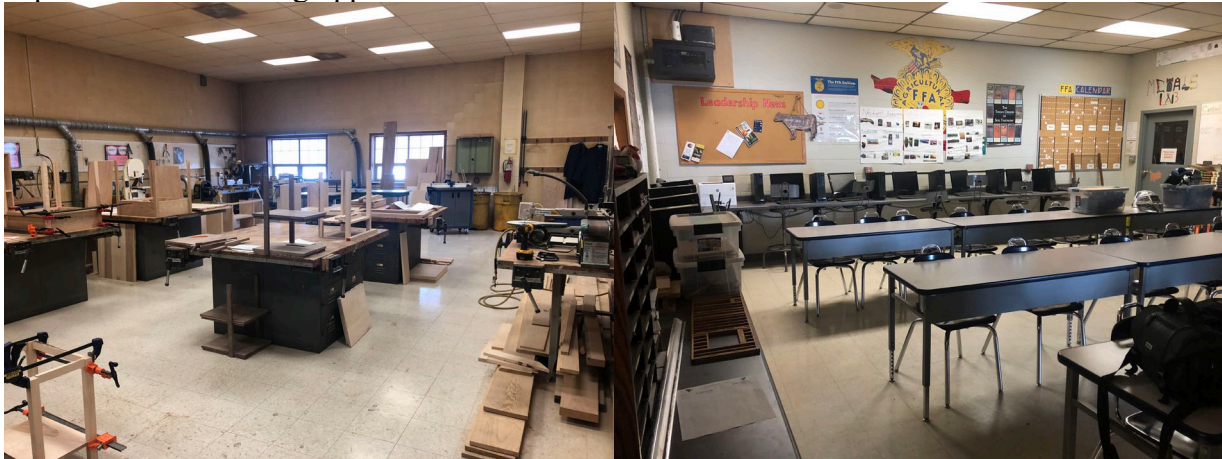
Wood shop lacks open space, adequate lighting Agriculture classroom is congested

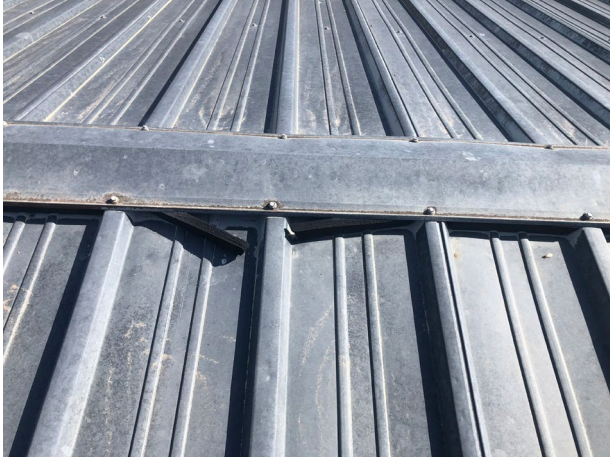
Deteriorated panel closures

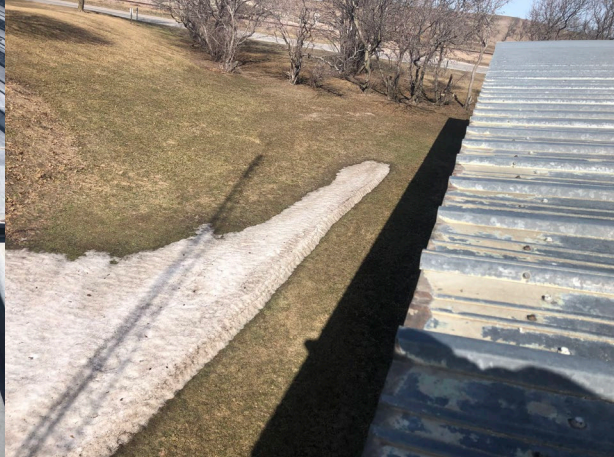
Missing gutters, evidence of rust beginning

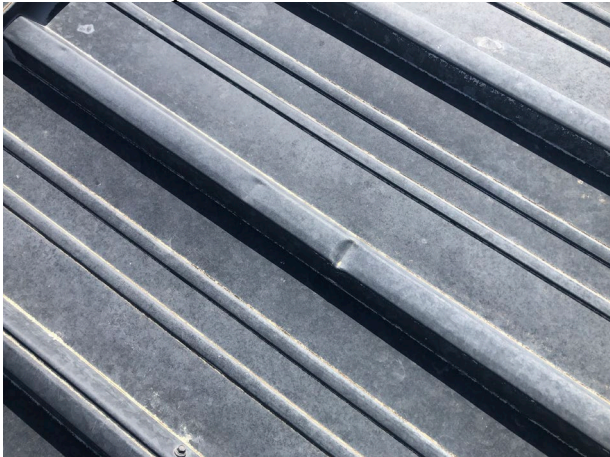
Finish gone, hail damage present

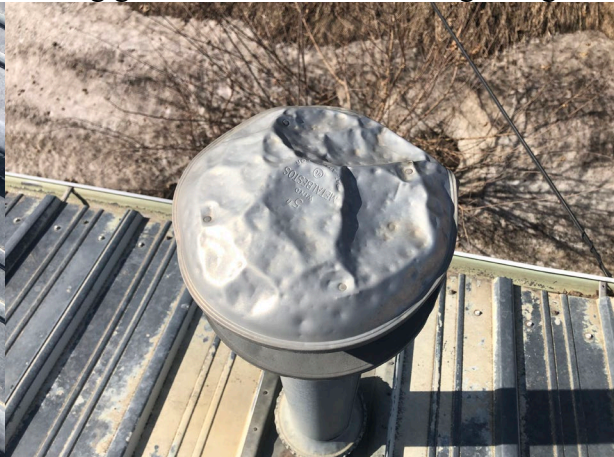
Hail damage

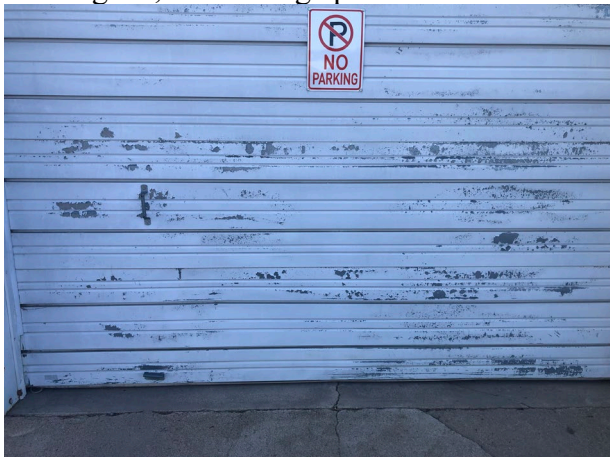
Damage to finish on overhead doors

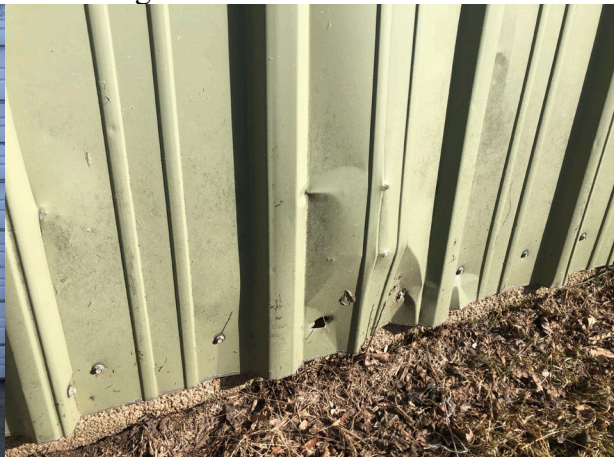
Typical siding damage

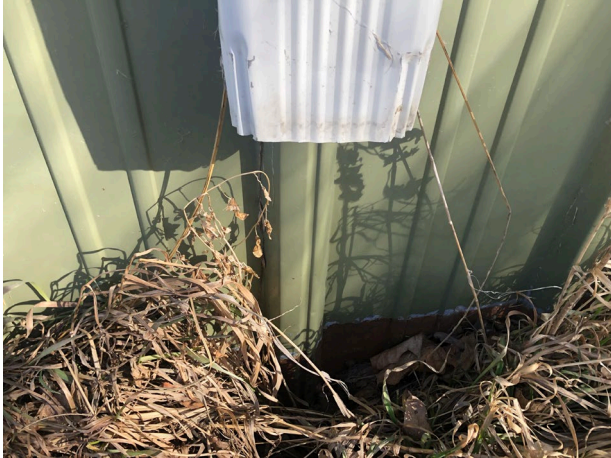
Missing splash block and downspout

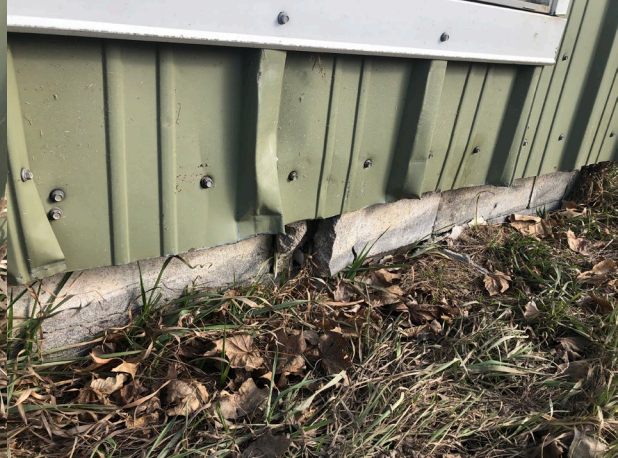
Broken CMU and cracked mortar

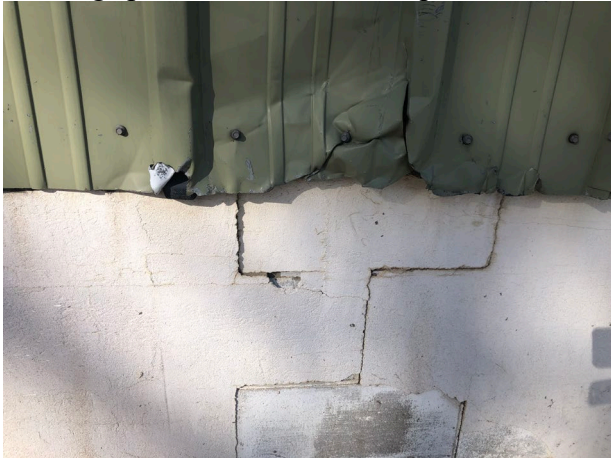
Siding and CMU damage

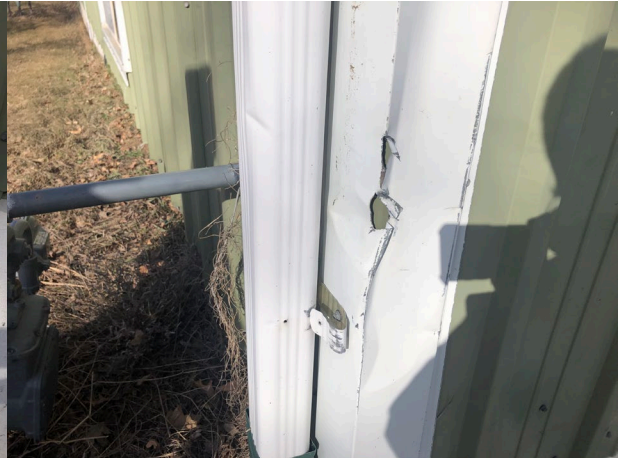
Damage to corner trim and downspout strap

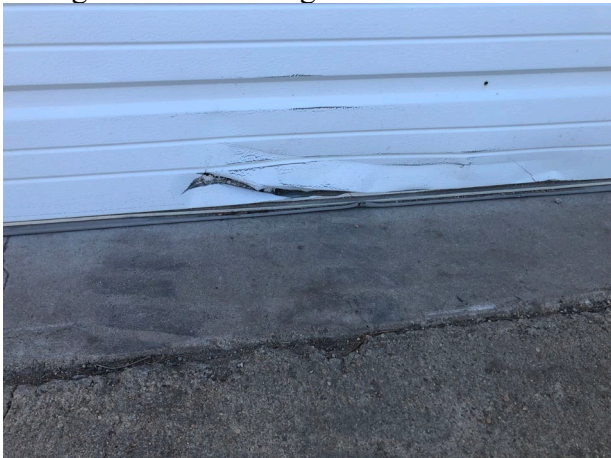
Overhead door damage

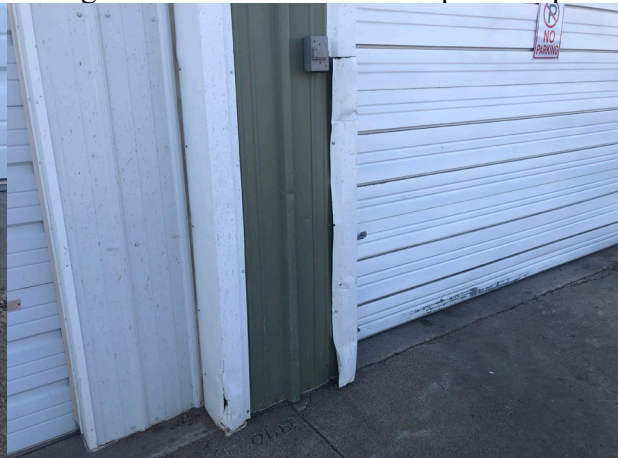
Typical damage at overhead door jambs

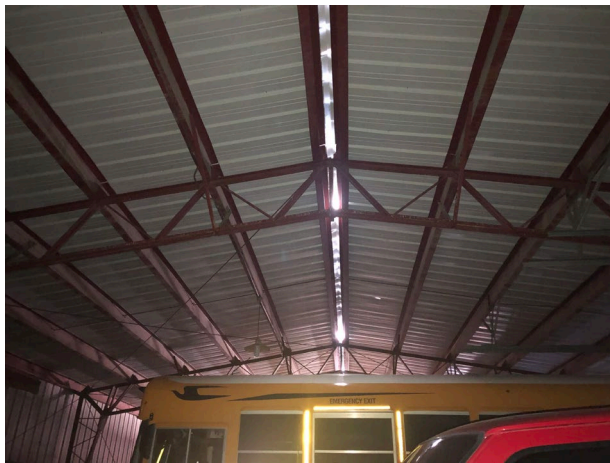
Panel closures along the ridge compromised

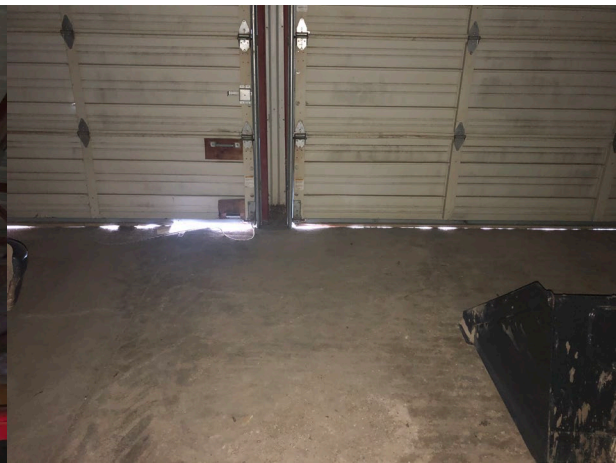
Overhead door seals damaged or missing

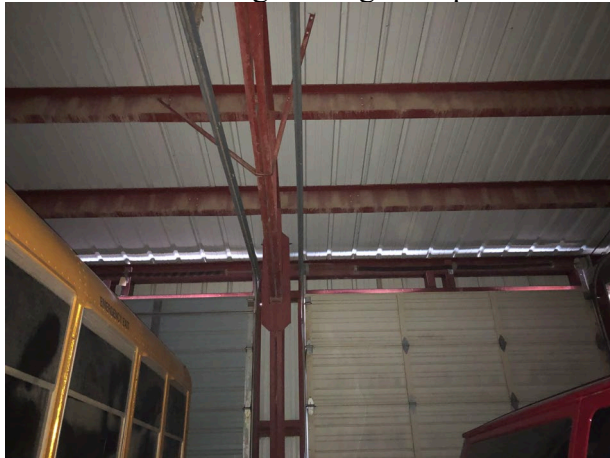
Panel closures at eaves missing

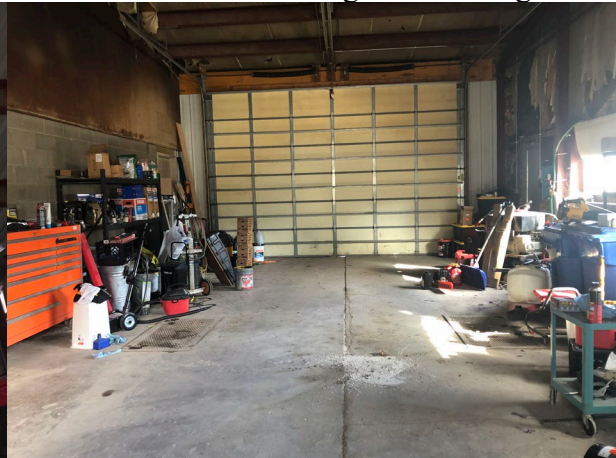
Repair bay is cramped and not long enough

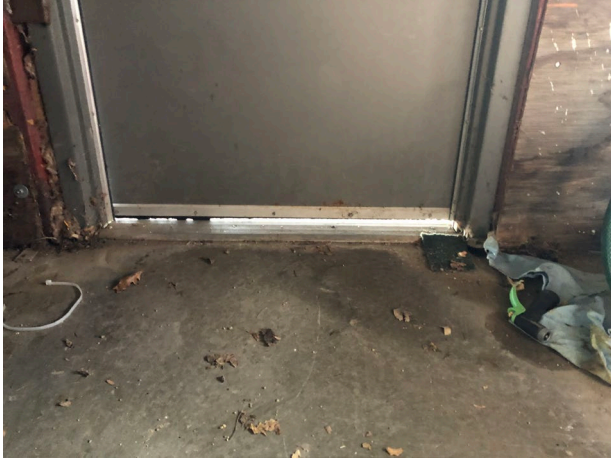
Walk door seals damaged

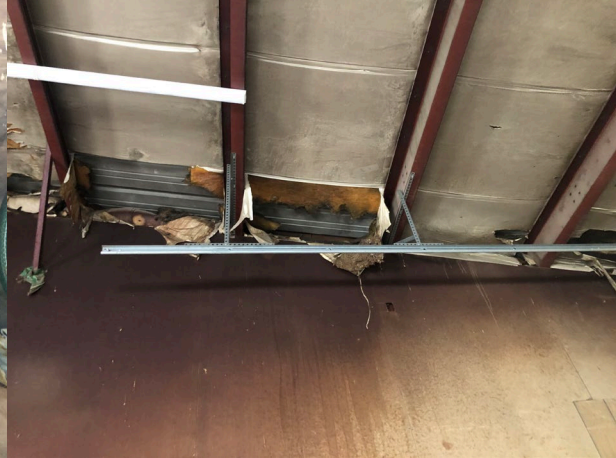
Existing insulation inadequate and damaged

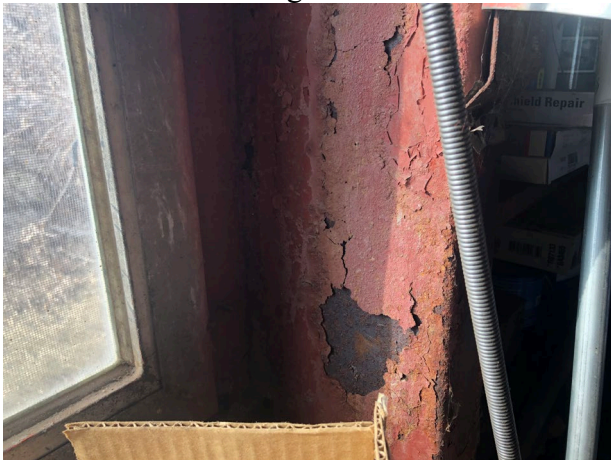
Rust and finish damage on main frame  
Windows are single pane and not thermally broken.

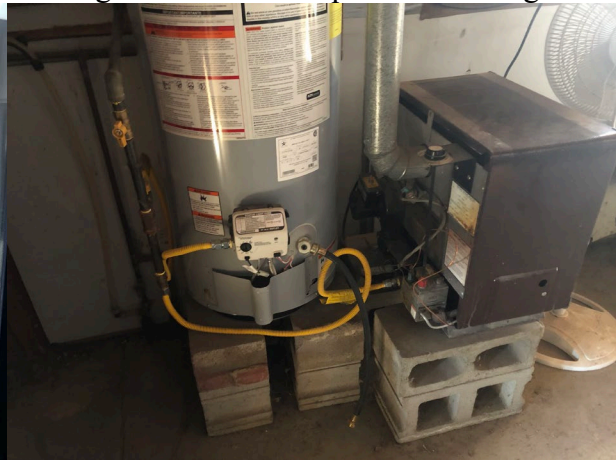
Water heater and space heater are exposed in the office. The smell of gas/exhaust evident
