**FACILITY AUDIT & MASTER PLAN**

**RANDOLPH PUBLIC SCHOOLS**

**MARCH 11, 2024**

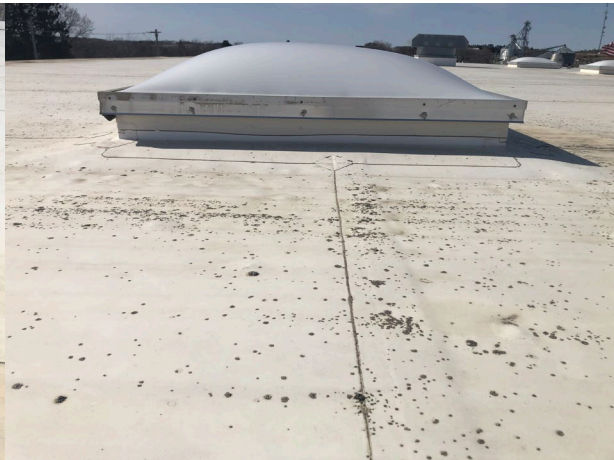
Algae should be removed to extend the life of the roofing

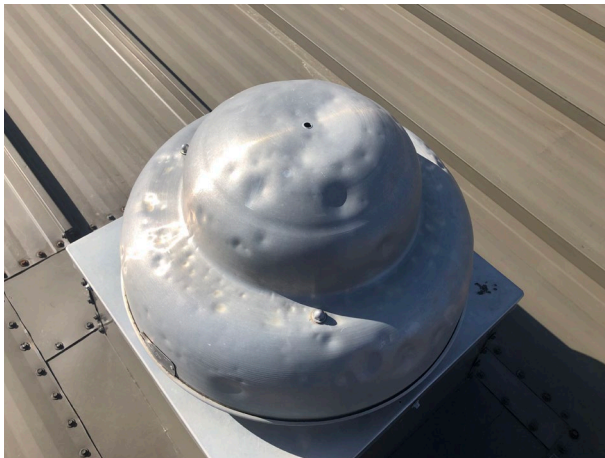
Hail damage to exhaust hood

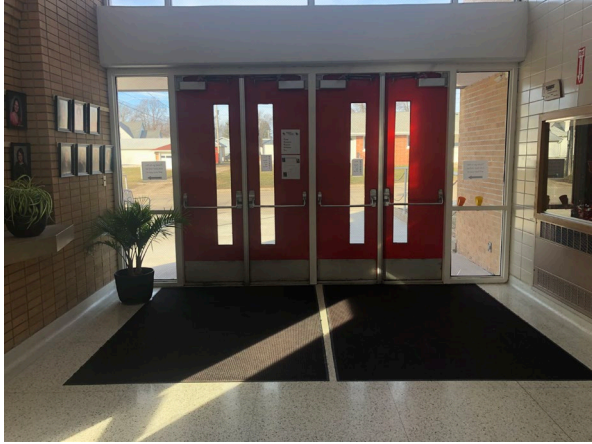
Main entry doors are too narrow to meet ADA

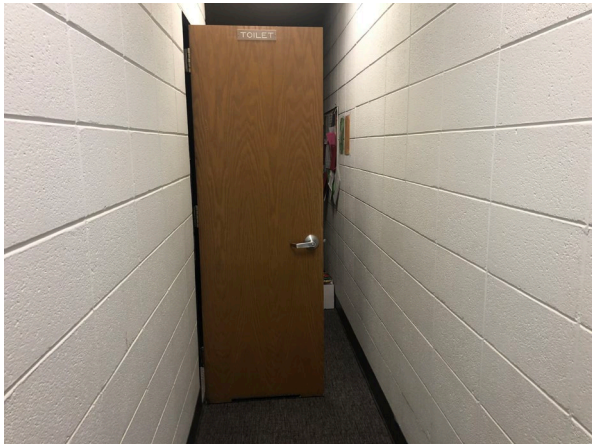
Maneuvering space at this door does not meet ADA

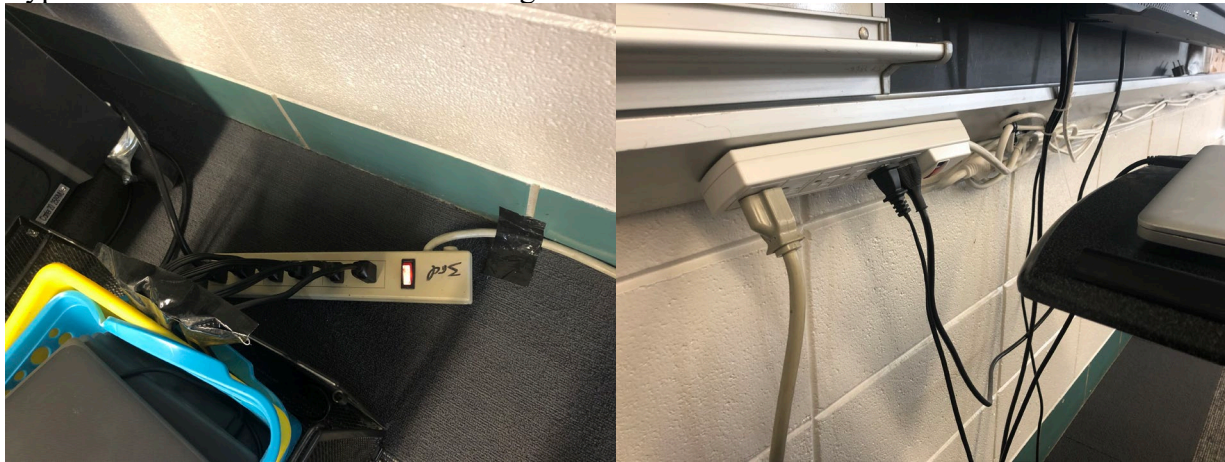
This 6 plug multi-outlet was plugged into.....this 6 plug outlet which was fed by an extension cord. This is a typical problem.

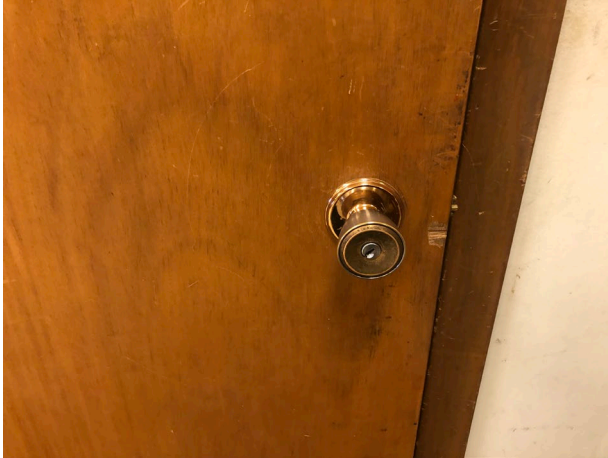
Interior hollow core residential door used for classroom door. Provides poor security and will not stand up to abuse. Note non ADA door hardware

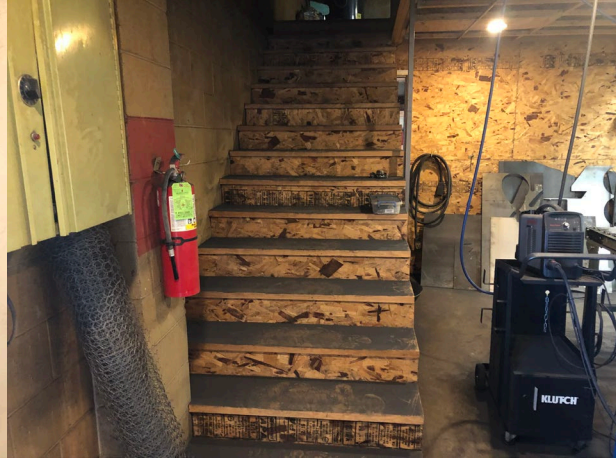
Metals shop mezzanine stair lacks guard and hand rails.

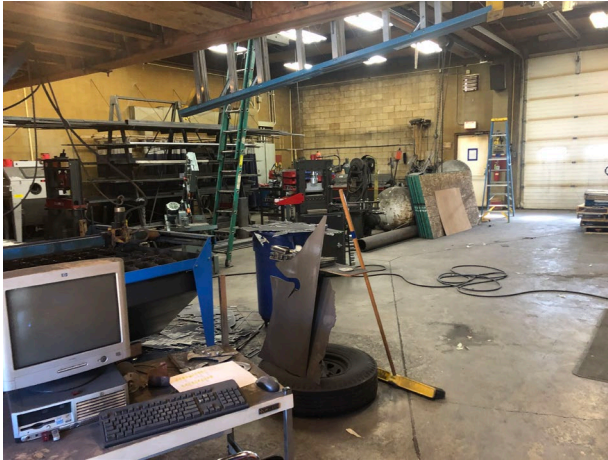
Metals shop lacks equipment  
Exposed CMU exterior wall little or no Insulation.

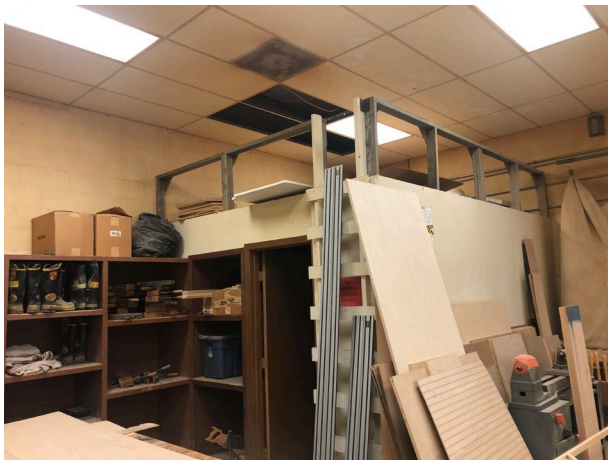
Wood shop lacks storage space

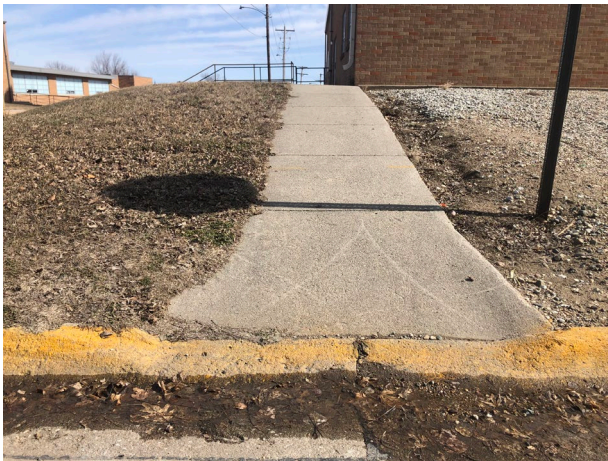
Non-compliant sidewalk and curb ramp

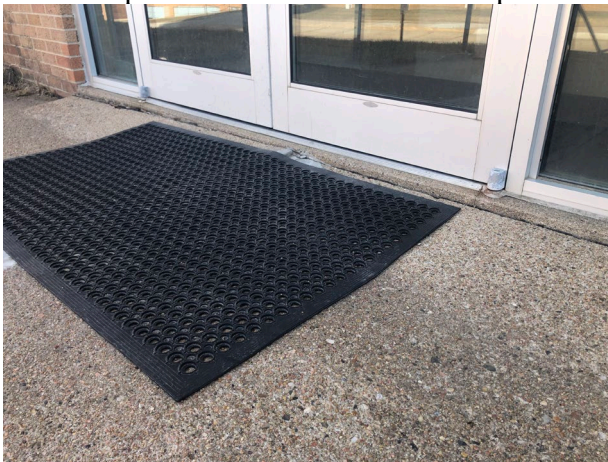
Vertical rise at entry door exceeds ADA

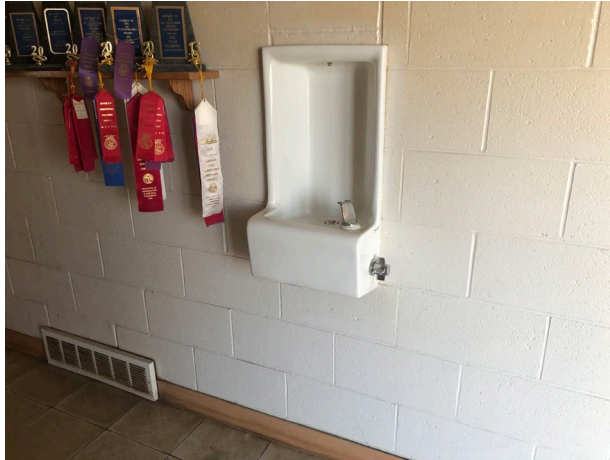
No knee and toe clearance at water fountain  
Fountain should also be a high/low model

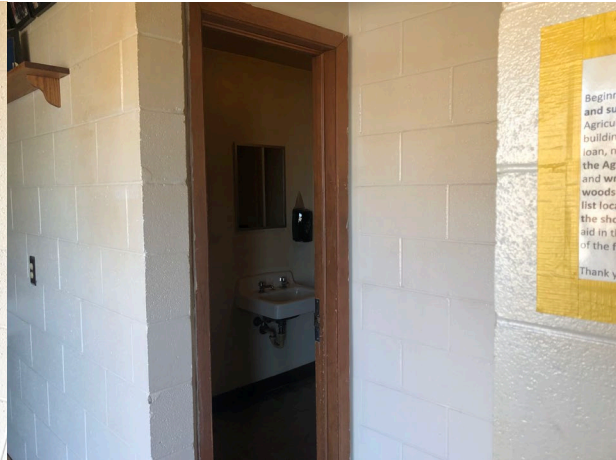
Restroom doors too narrow to allow wheelchairs

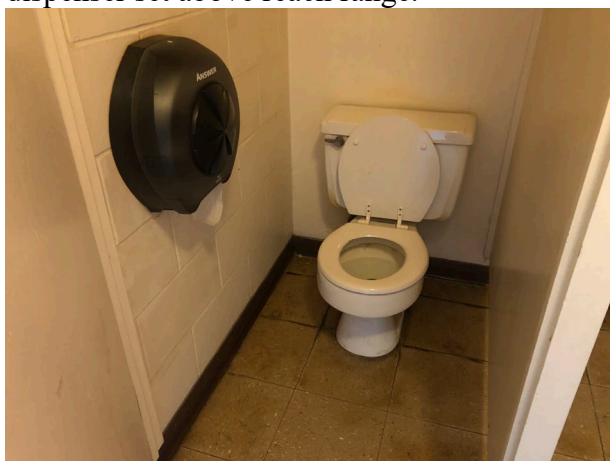
No grab bars, flush on wrong side,  
No maneuvering area, paper towel dispenser not in correct location

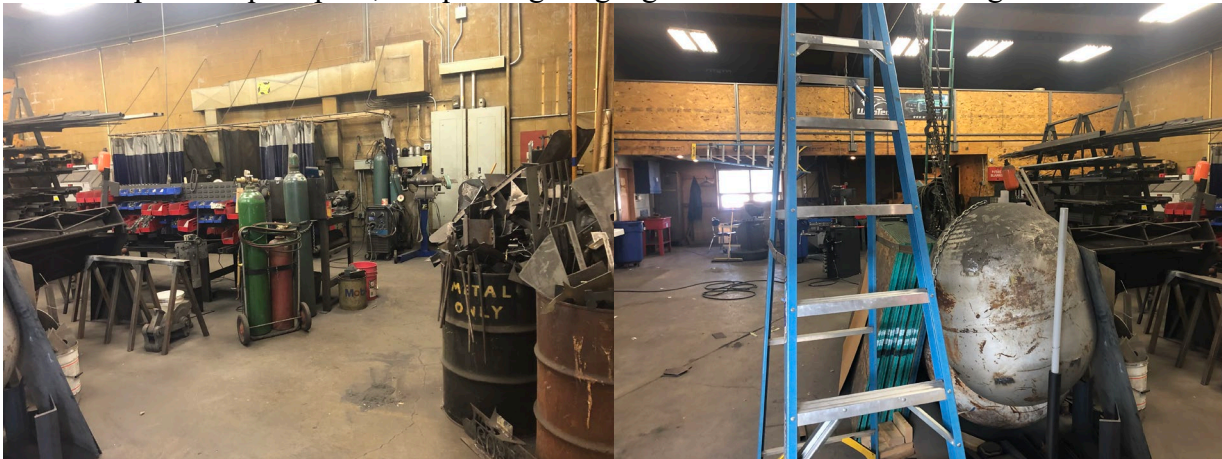
Metals shop lacks equipment

Metals shop lacks sufficient open space
