**FACILITY AUDIT & MASTER PLAN**

**RANDOLPH PUBLIC SCHOOLS**

**MARCH 11, 2024**

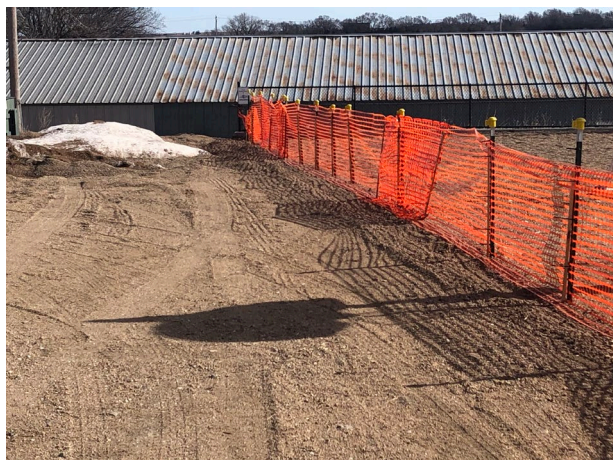
Existing barrier between parking and playground is not adequate protection. A vehicle barrier and a permanent chain link fence would be more appropriate

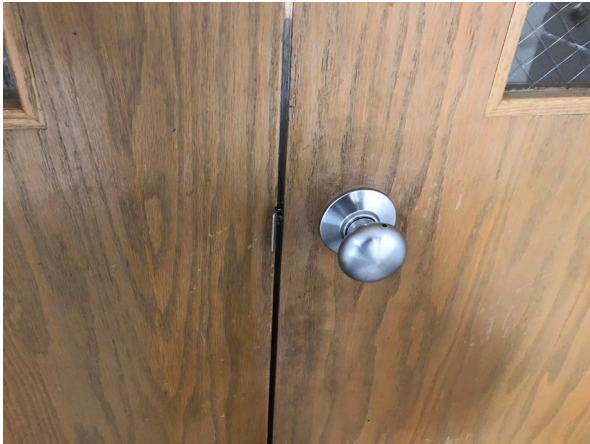
Gymnasium door hardware does not meet ADA

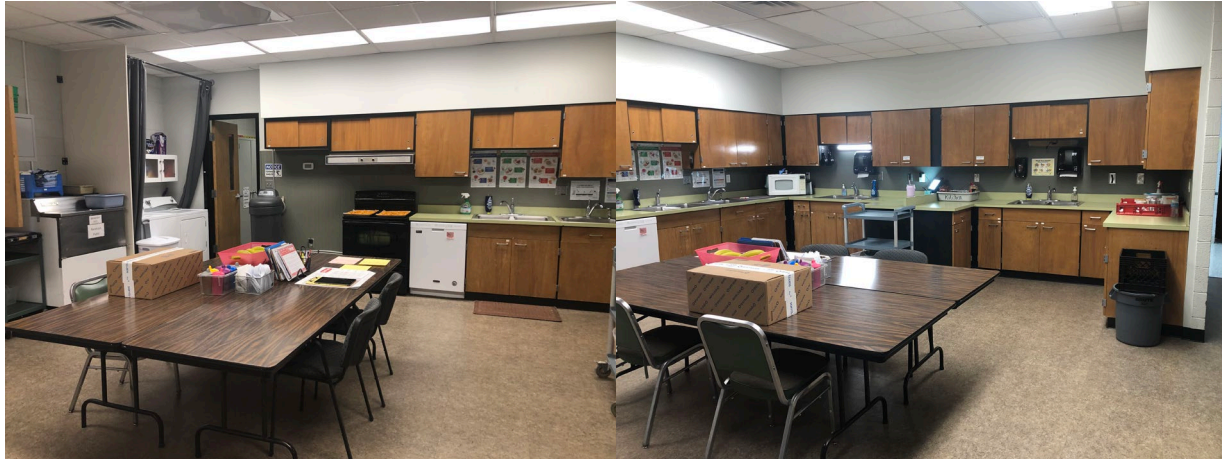
Washers and dryers are not allowed in kitchens according to the Nebraska Food Code

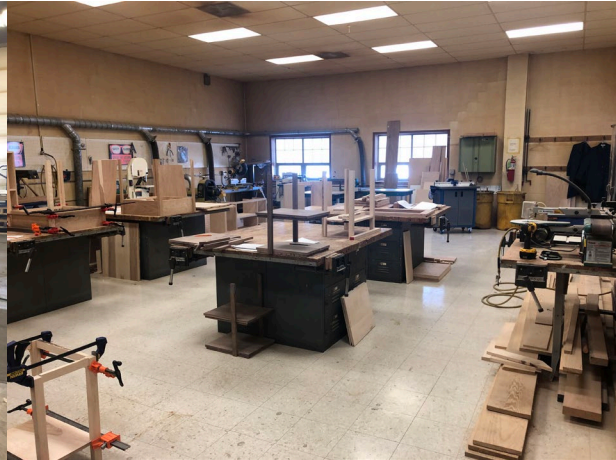
Wood shop lacks open space, adequate lighting

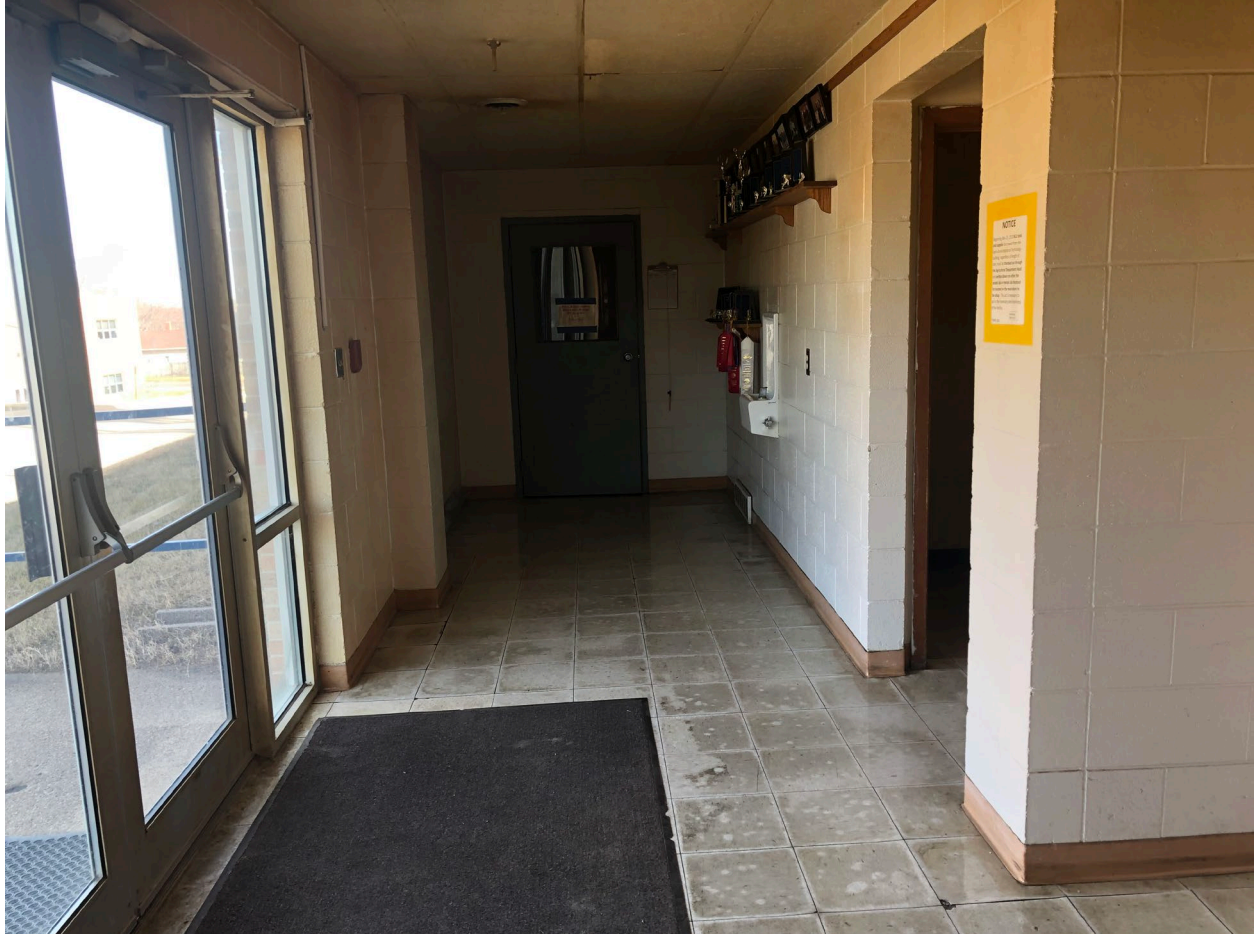
There is no security vestibule. Once inside, a person has access to both shop doors. The metals shop shown here has a large glass opening, and the woods shop is a hollow core residential door.
